Building Moisture Survey

**Steve Etzler
181 Wrenfield Way
Harleysville PA 19438**

The property at 181 Wrenfield Way Harleysville PA, 19438 was the subject of a visual, moisture meter or an infrared (IR) survey on 7/15/2014. Areas agreed and designated by the client for this survey are listed in this document.

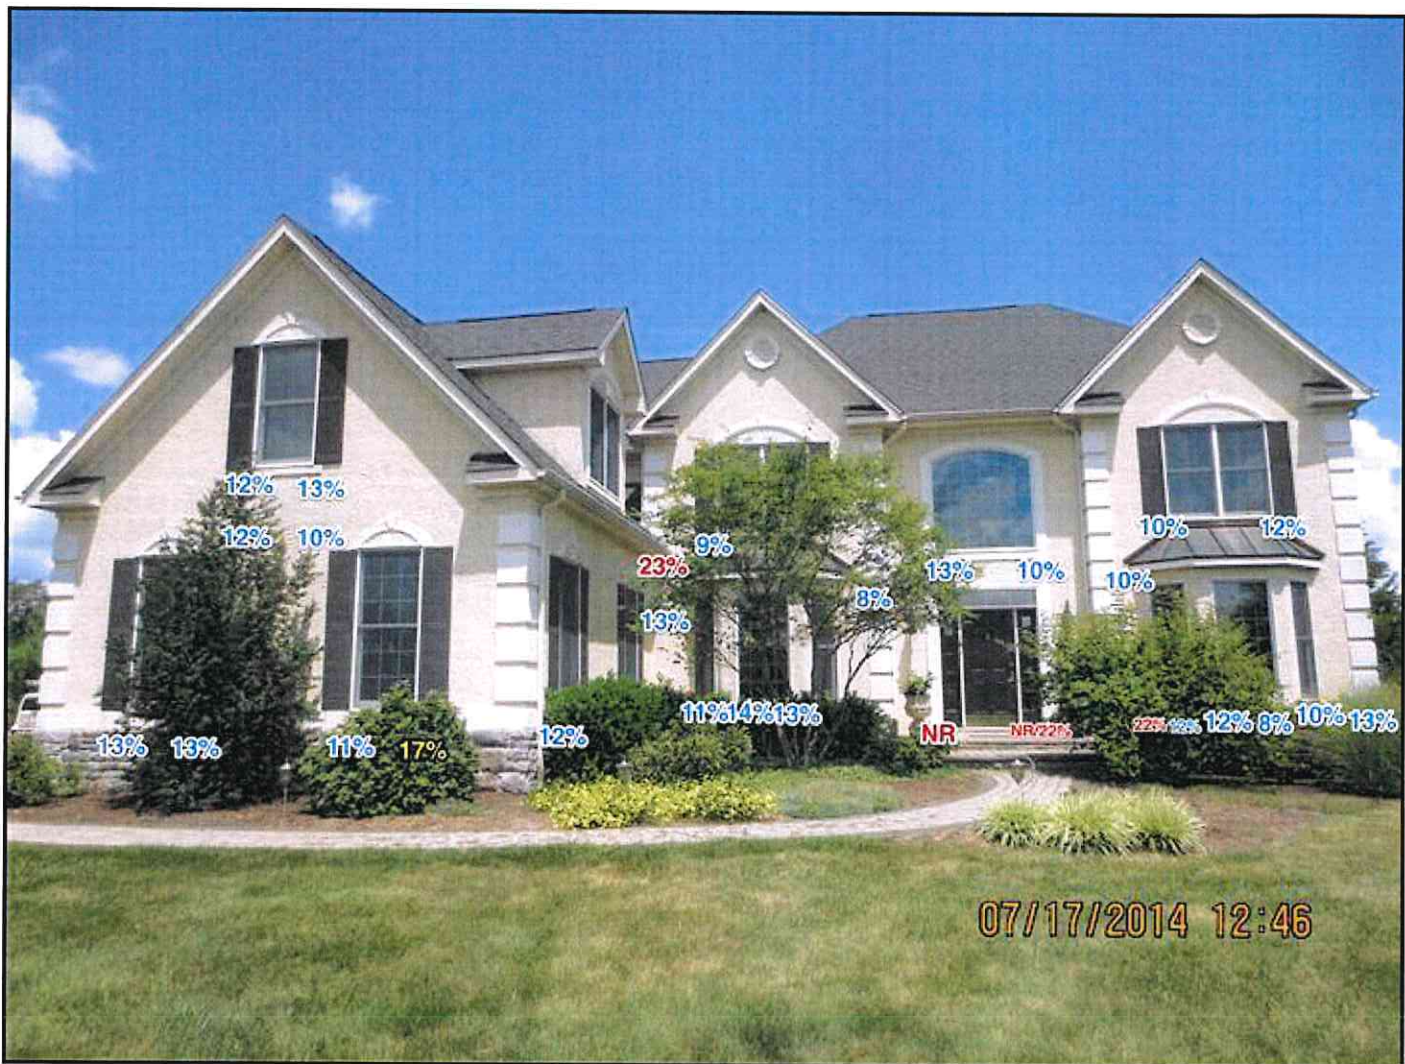
2.0 Item 1(Picture)

- **Observation:** Elevated moisture levels noted on this elevation.
- **Observation:** No resistance of the sheathing was noted on this elevation.
- **Observation:** Missing kickout flashing was noted on this elevation.
- **Observation:** A weep screed was not installed on this elevation to help assist with drainage and to reduce capillary action.
- **Observation:** The stucco is not adequately terminated or sealed around the windows, doors and other penetrations.
- **Observation:** The stucco is not adequately terminated or sealed at the fascia boards, rake boards, soffit returns and other terminations.
- **Recommendation:** We recommend destructive testing with further review and a remediation plan set in place.

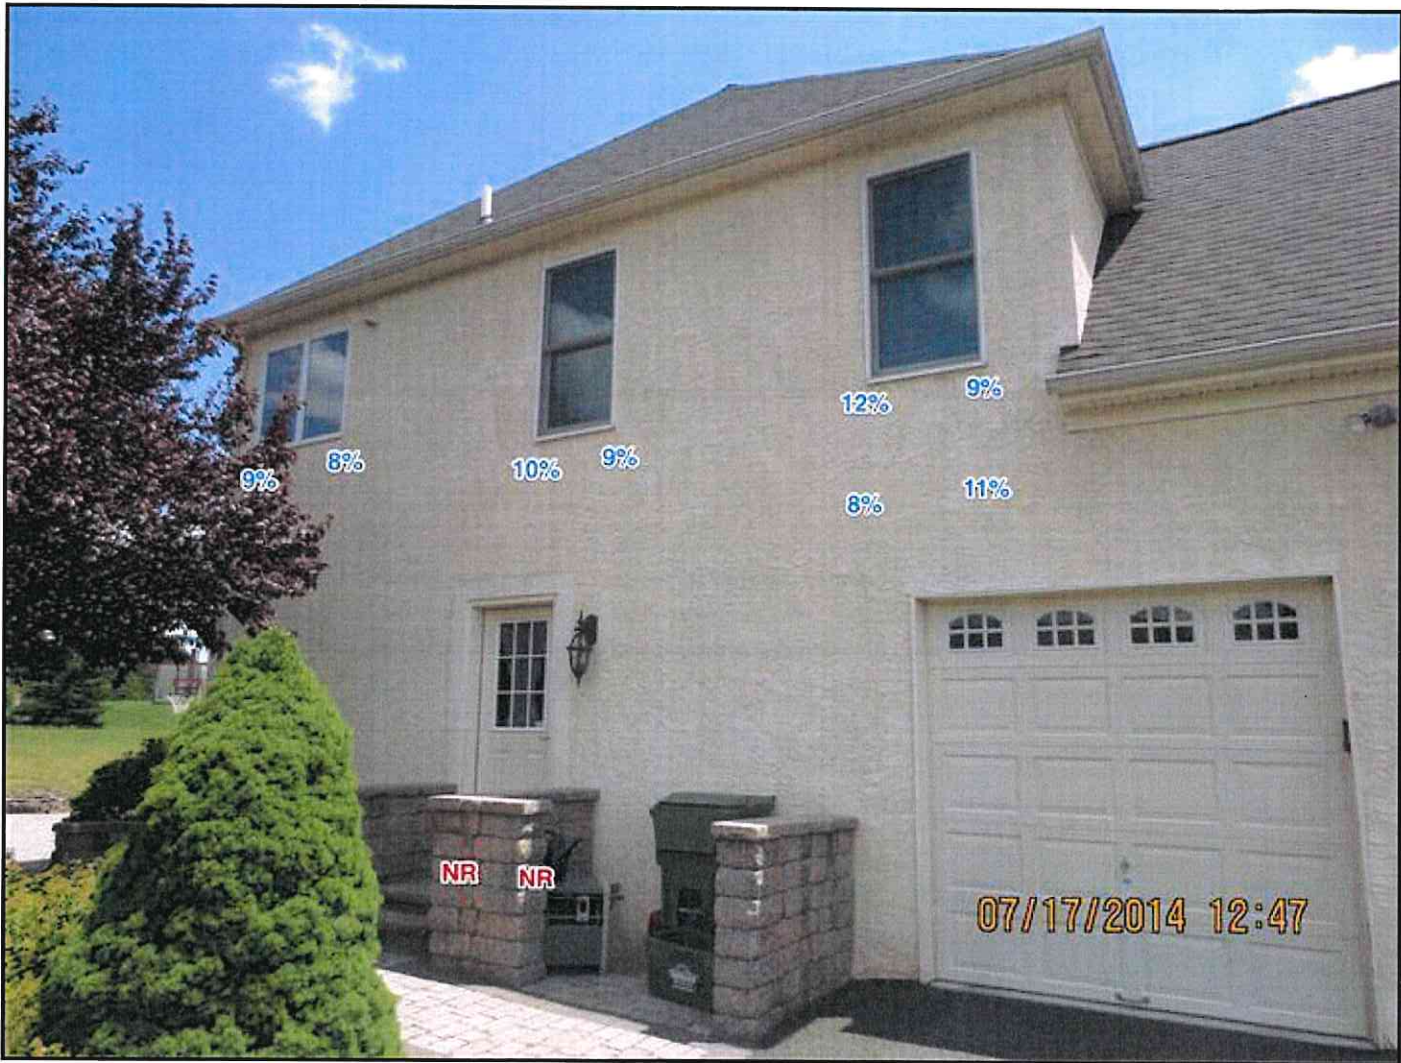
3.0 Item 1(Picture)

- **Observation:** No resistance of the sheathing was noted on this elevation.
- **Observation:** A weep screed was not installed on this elevation to help assist with drainage and to reduce capillary action.
- **Observation:** The stucco is not adequately terminated or sealed around the windows, doors and other penetrations.
- **Observation:** The stucco is not adequately terminated or sealed at the fascia boards, rake boards, soffit returns and other terminations.
- **Recommendation:** We recommend destructive testing with further review and a remediation plan set in place.

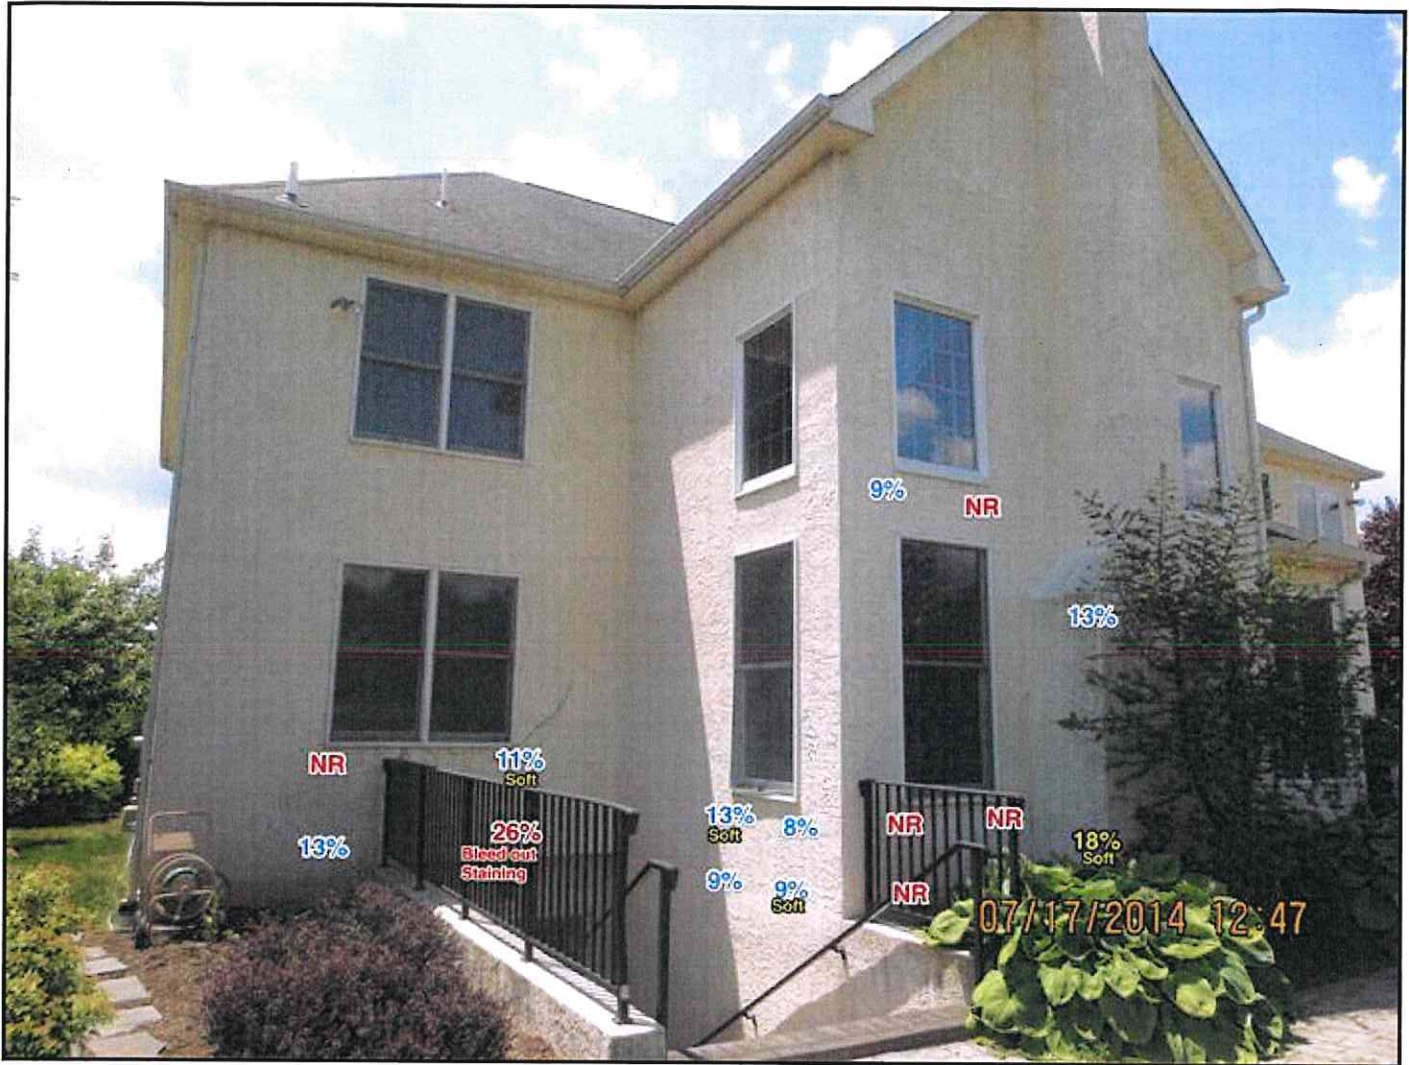
4.0 Item 2(Picture)

- **Observation:** Elevated moisture levels noted on this elevation.
- **Observation:** No resistance of the sheathing was noted on this elevation.
- **Observation:** Inadequate kickout flashing was noted on this elevation.
- **Observation:** A weep screed was not installed on this elevation to help assist with drainage and to reduce capillary action.
- **Observation:** The stucco is not adequately terminated or sealed around the windows, doors and other penetrations.
- **Observation:** The stucco is not adequately terminated or sealed at the fascia boards, rake boards, soffit returns and other terminations.
- **Recommendation:** We recommend destructive testing with further review and a remediation plan set in place.

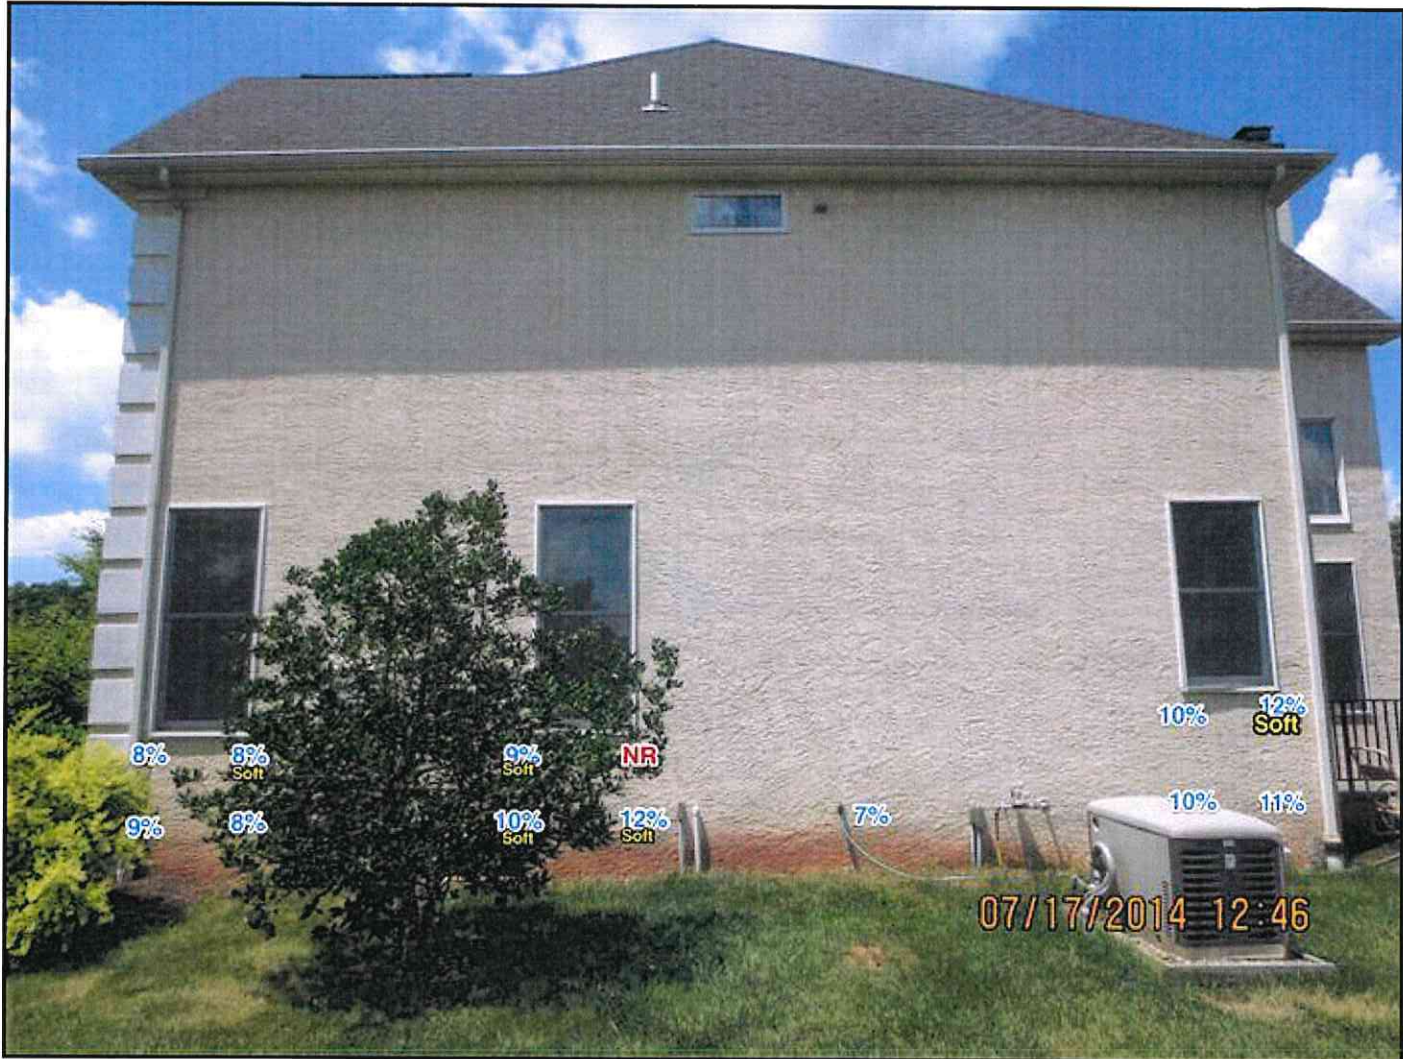
5.0 Item 1(Picture)

- **Observation:** Soft sheathing was noted on this elevation.
- **Observation:** No resistance of the sheathing was noted on this elevation.
- **Observation:** A weep screed was not installed on this elevation to help assist with drainage and to reduce capillary action.
- **Observation:** The stucco is not adequately terminated or sealed around the windows, doors and other penetrations.
- **Observation:** The stucco is not adequately terminated or sealed at the fascia boards, rake boards, soffit returns and other terminations.
- **Recommendation:** We recommend destructive testing with further review and a remediation plan set in place.

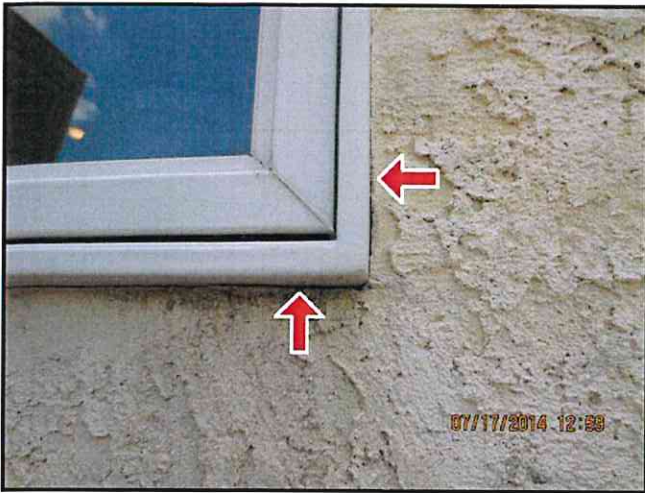
6.0 Item 1(Picture)

6.0 (1) The stucco is not adequately terminated or sealed around the windows, doors or other terminations.

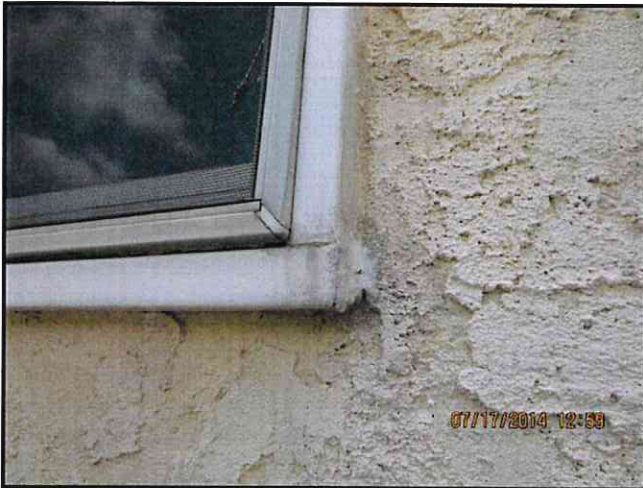
6.0 Item 2(Picture)

6.0 (2) Some windows have been caulked post construction.

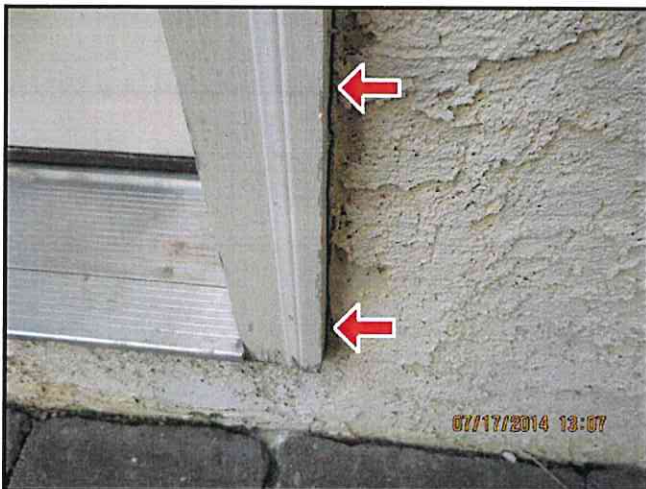
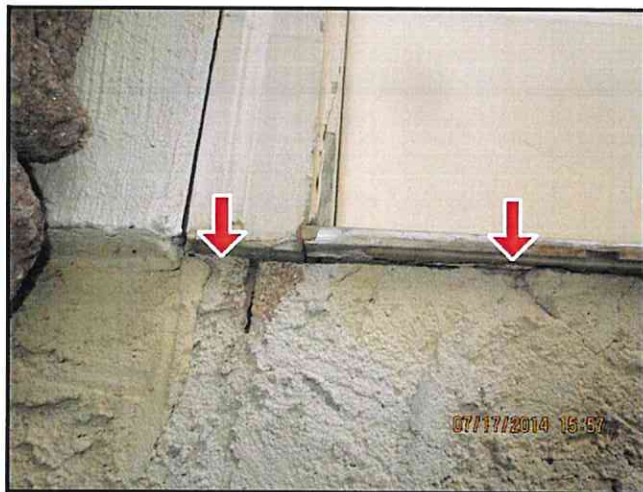
6.1 The stucco is not adequately terminated or sealed around the windows and doors or other penetrations.

The stucco is not properly terminated or sealed around the windows and doors. This poses expansion stresses on the windows or doors that can cause the miter joints to fail prematurely, cracking and/or the introduction of bulk water to the wall cavities.

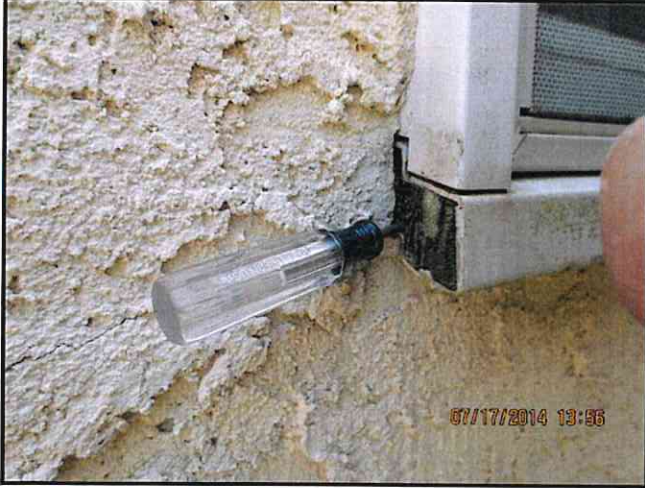
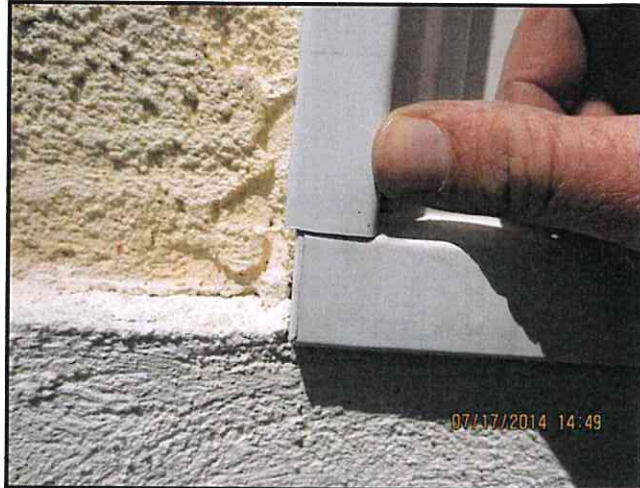
6.2 The window miter joints are a concern. Some joint movement was noted in various locations. This can directly lead to unseen bulk water intrusion. We recommend proactive correction in order to try and avoid a potential future

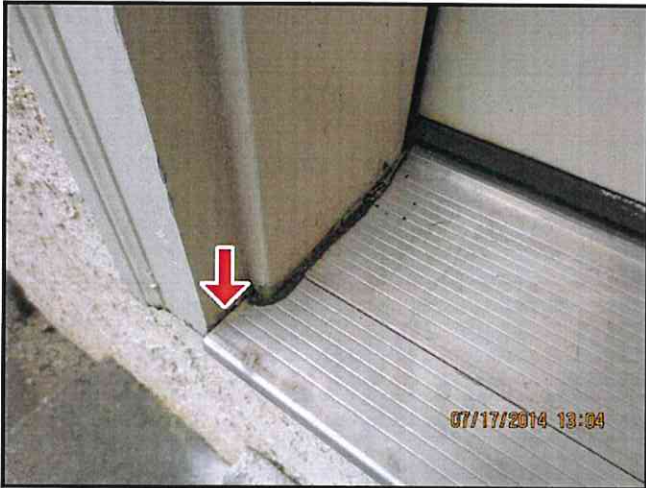
6.3 Item 1(Picture)

6.3 Openings and voids in the sill and jamb intersection can lead to bulk water intrusion. The best way to help manage moisture entry is with the use of proper sill pan flashing installed under the windows and doors with the use caulking as well.

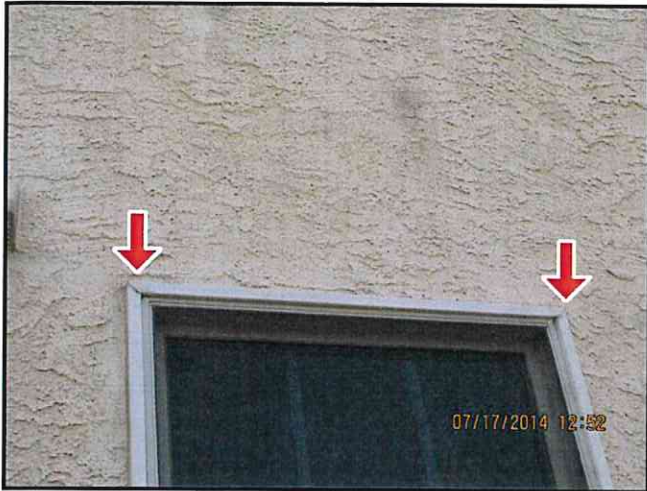
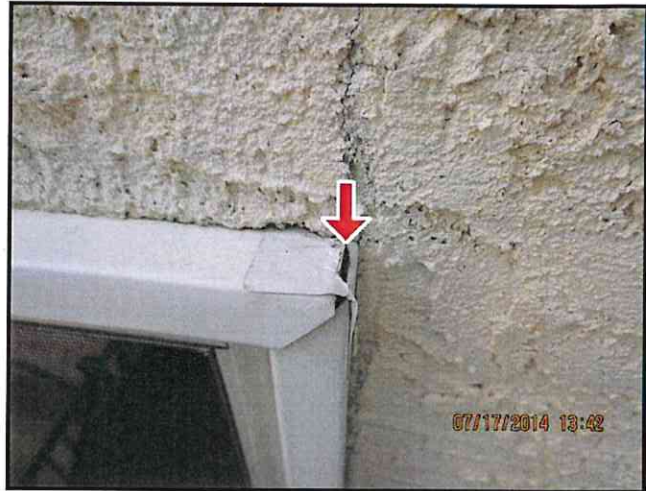
6.4 Window head flashing was missing. Head flashing helps to assist draining bulk water to the exterior and well as protect the window.

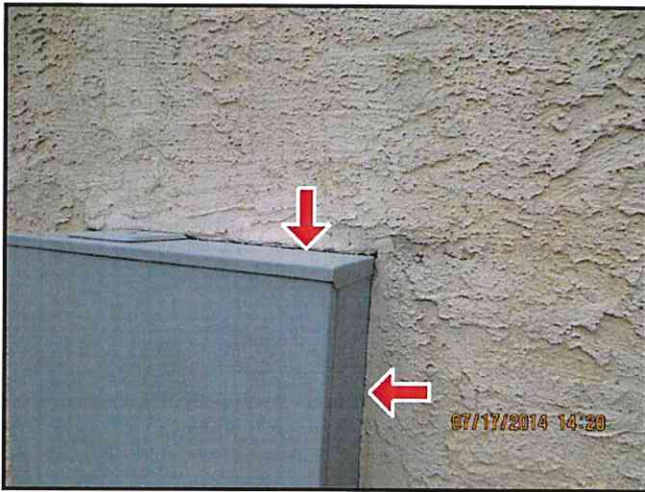
6.6 Item 1(Picture)

6.6 (1) The stucco is not adequately terminated, flashed or sealed around the electrical meter box.

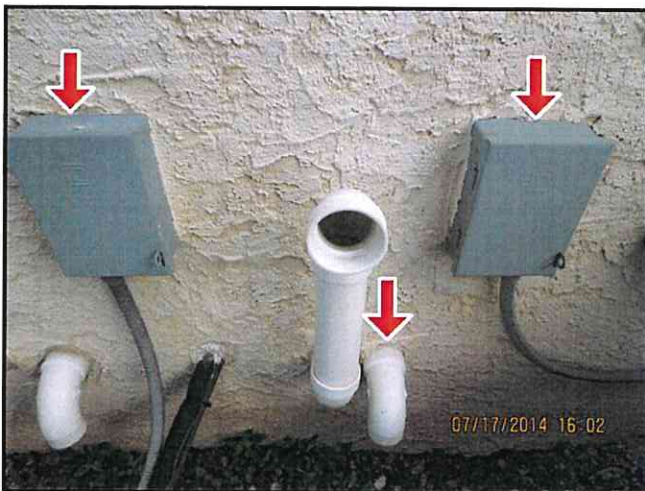
6.6 Item 2(Picture)

6.6 (2) The stucco is not adequately terminated or sealed around the utility penetrations.

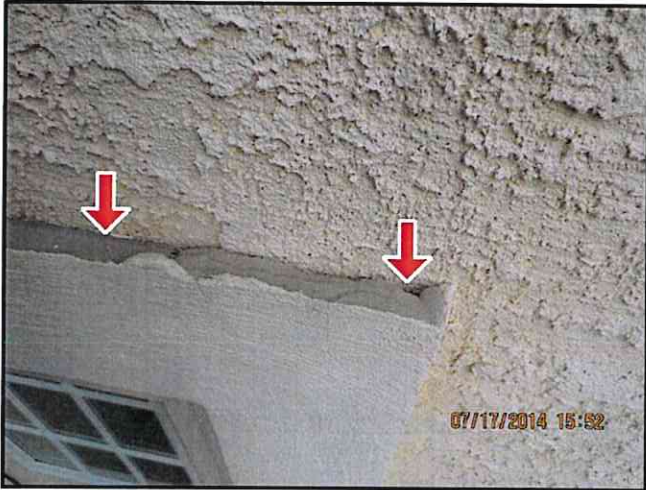
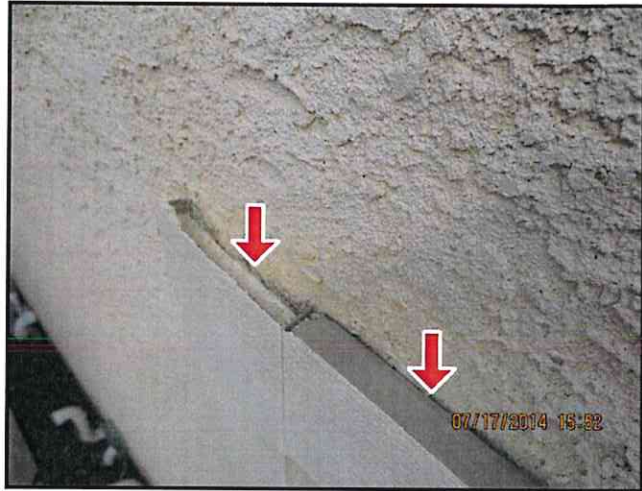
6.8 Flat accent bands were installed around the windows. Flat accents have been known to hold and potentially push bulk water behind the bands which can lead to excess moisture being trapped which may overwork the weather resistant barriers. All flat accents are recommended to be caulked and sealed at minimum, a more pro-active approach would be to pitch the flat sills along with sealing in order to help shed bulk water.

The entrance door on the left side of the home had an EIFS band installed. Visible EPS board was noted.

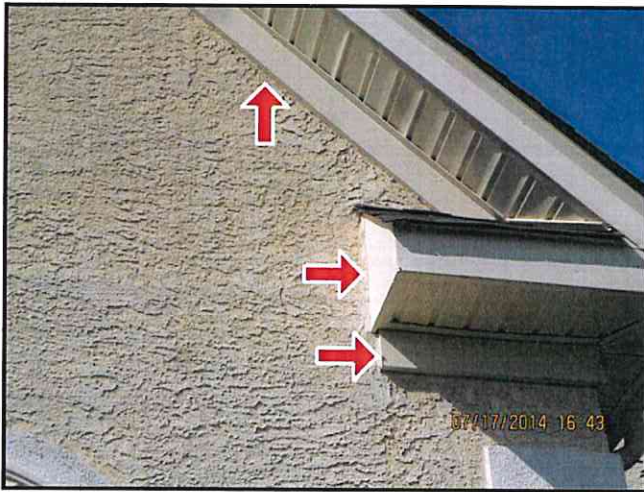
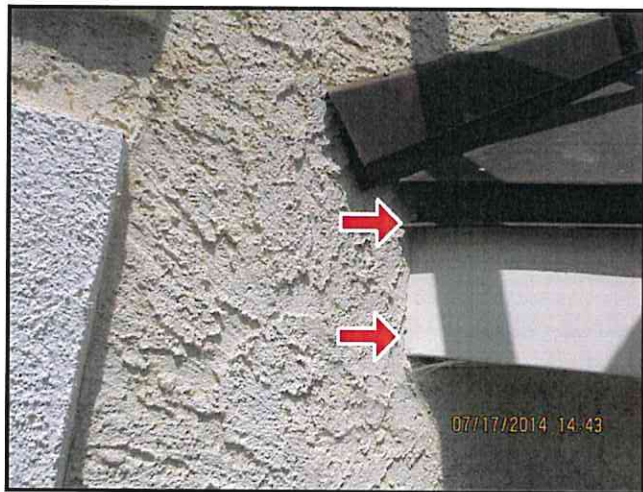
6.9 The stucco is not properly terminated or sealed at the rake boards, fascia boards, soffit returns or other terminations.

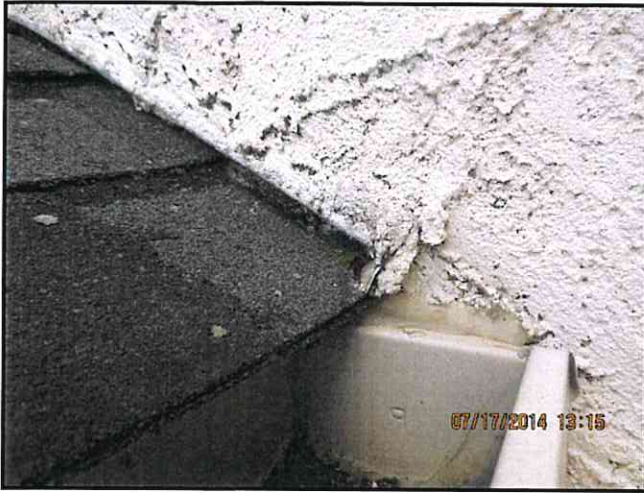
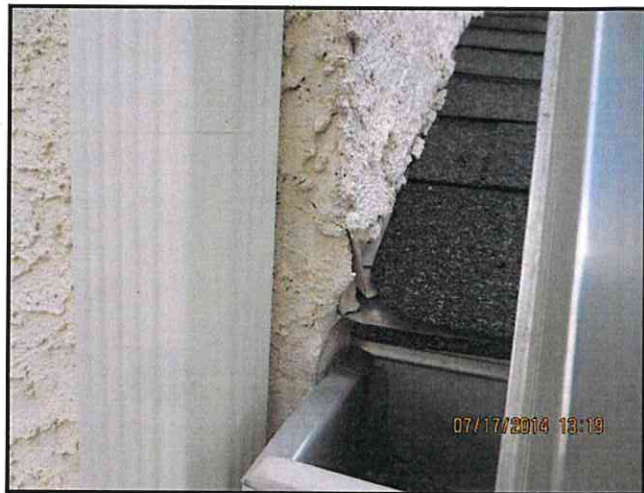
6.10 Inadequate kickout flashing was installed at the roof/wall intersections.

Inadequate kickout flashing was installed. Kickout flashing is a special type of flashing located at roof/wall intersections that diverts rain water away from the cladding and into the gutter. When installed properly, they provide excellent protection against the penetration of water into the building envelope. Several factors can lead to rain water intrusion, but a missing kickout flashing, in particular, often results in concentrated areas of water accumulation and potentially severe damage to exterior walls. Water penetration into the cladding can occur with little or no visible evidence on the exterior.

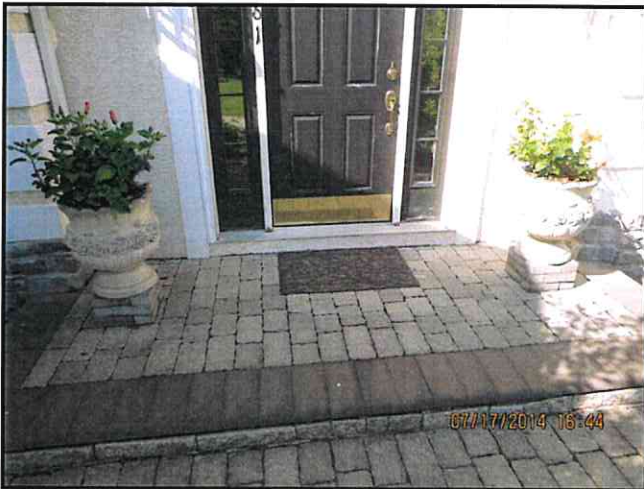
6.14 Item 1(Picture)

6.14 The paver stoop has been installed above the homes framing line without the visible installation of adequate drainage provisions. This may cause excessive moisture to be held against the home which can overwork the weather resistant barriers causing elevated moisture levels in the wood framing directly behind this location.

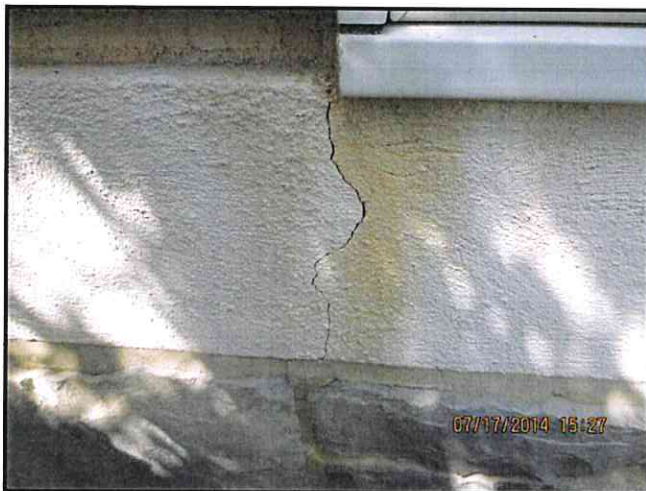
7.3 Item 1(Picture)

7.3 Cracks were noted.

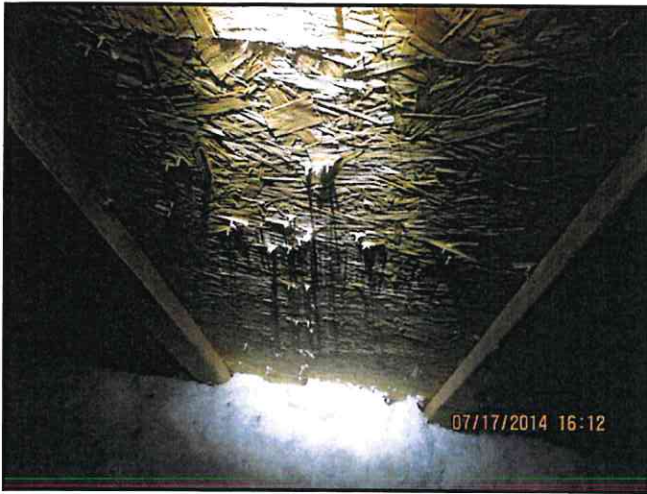
7.12 Item 1(Picture)

7.12 Slightly excessive fastener patterns were found between the framing studs. Besides having excess penetrations of the water resistant barrier which may cause problems in itself, this excessive fastener pattern may lead to condensation and elevated moisture levels in the wall cavities during winter months from thermal conductivity. It presents a cold metallic object inside of a warm wall cavity in heated portions of the home.

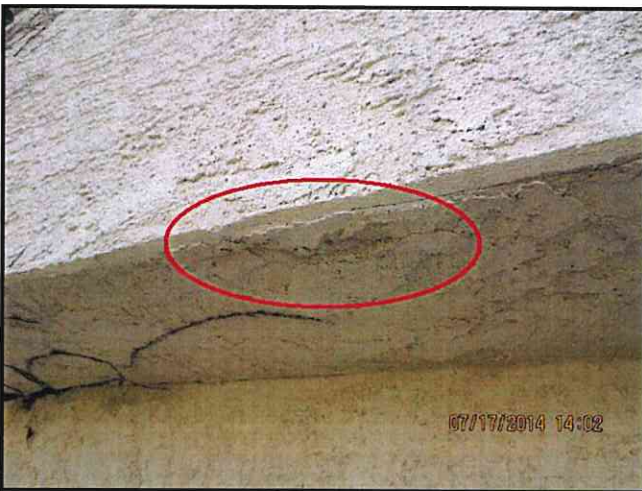
7.16 Item 1(Picture)

7.16 Staining consistent with OSB bleed out was noted under the bump out at the rear of home.
